Fighting Freeze and Failures:

A Tribal School's Wastewater Crisis Meets a Cold Reality

Suzan Chin-Taylor, MSc

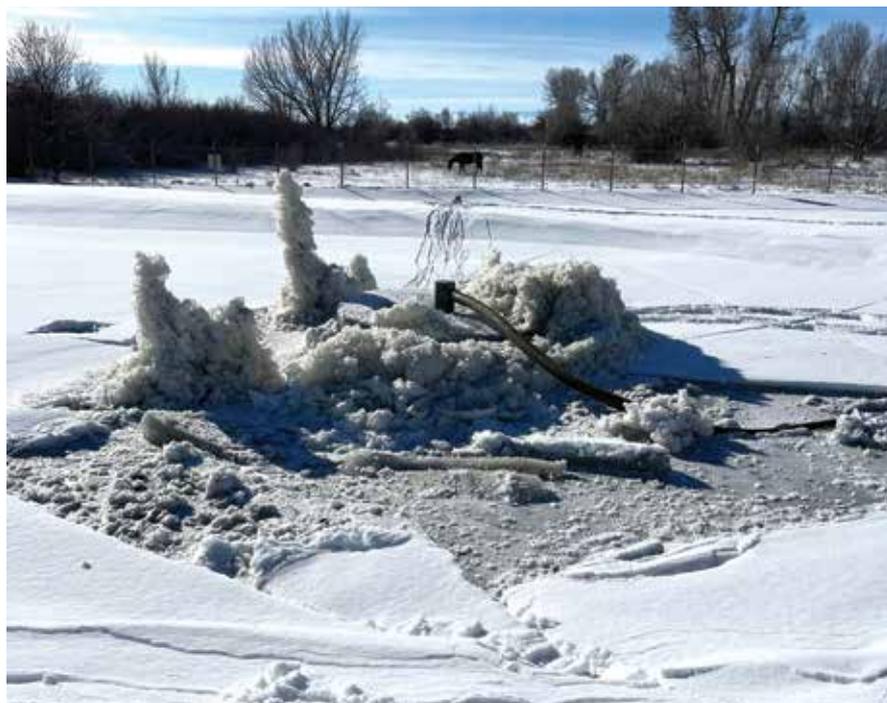
Titus Wastewater Solutions Twister FL (Floating Aerator) in operation at St. Stephen's School Wastewater Treatment Lagoon.

Titus eventually secured emergency authorization. But by the time his team arrived, the lagoon was buried under 15 inches of snow, and the surface ice was nearly a foot thick. With temperatures plunging into the single digits, the crew couldn't even get close without a front-end loader clearing the road.

Breaking the ice was another matter. A thousand-pound iron weight bounced off the frozen surface. Even an 18-inch auger only managed a small hole. Eventually, the team resorted to using the aerators themselves – each weighing nearly 3,000 pounds – as battering rams to widen the opening.

Somehow, the units withstood the abuse. Once installed, they faced another challenge: sludge. "They were sitting right on top of it," Titus explained. "We got them running, and they ate their way through it."

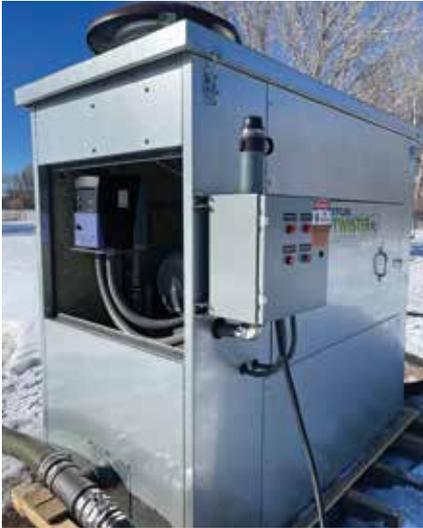
Titus Twister FL (Floating Aerator) control, power and air supply unit on the shore of the St. Stephen's School Wastewater Treatment Lagoon.

As temperatures dropped further, to as low as -44°F, the equipment remained operational, preventing the lagoons from freezing solid. Three months of 0 to minus 44-degree temperatures were the true test. A power outage, which shut down the blower, was the only real challenge. This went several days before maintenance personnel discovered the shutdown. The aerator's air pipe was frozen solid. Titus's team resorted to creative solutions to restart the aerators. They heated propylene glycol antifreeze on a stove inside the mission, poured it

into insulated coolers, and hand-delivered it down air pipes, melting the ice plug that was preventing air flow to the aerator diffuser. The system ran uninterrupted for the rest of that brutal winter.

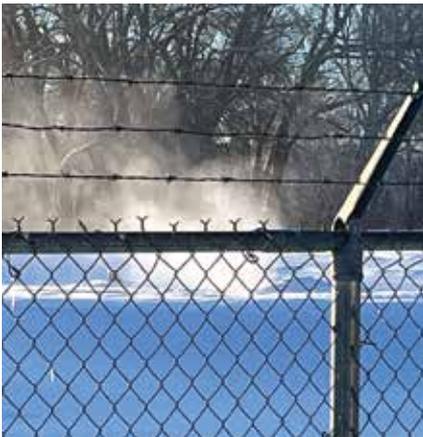
Lagoon the following winter, Twister FL still operating under the snow pack.

What started as a desperate intervention has proven durable and transformative. The aerators, still running three years later, have never broken down.

"To my knowledge, there's not been a single stoppage," said Father Drew. "They never froze up, even when it hit -44."

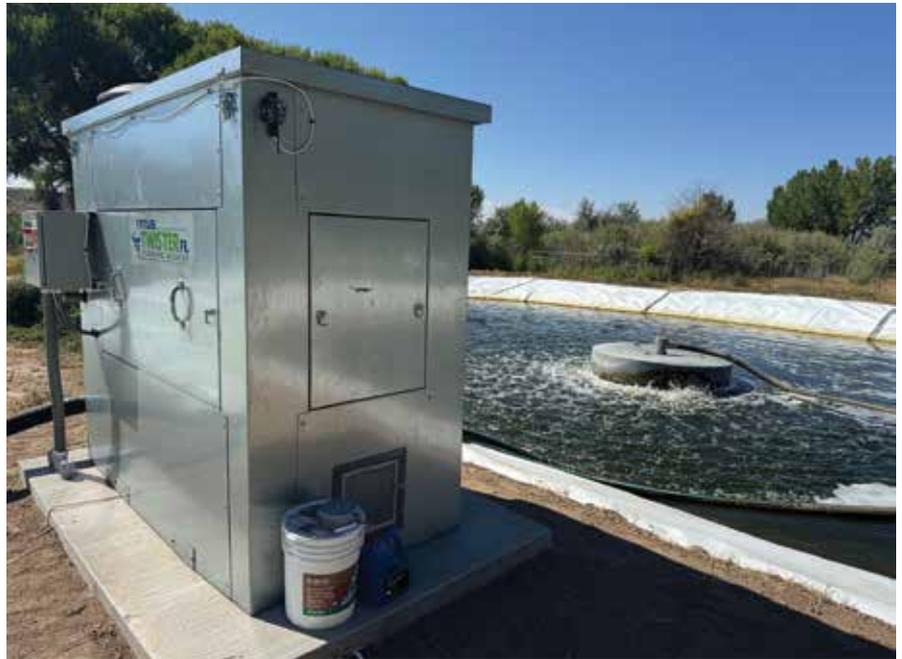
St. Stephen permanent structure pond in summer.

As the lagoons in this system are very shallow, the TITUS® FL-4 Floating Aerator was used in this project and operates with

a side-draw intake and a durable, self-contained design that reduces volatile solids significantly, while protecting the lagoon liner. Its floating platform allows it to function even in high-sludge environments, and it can oxygenate water at impressive distances.

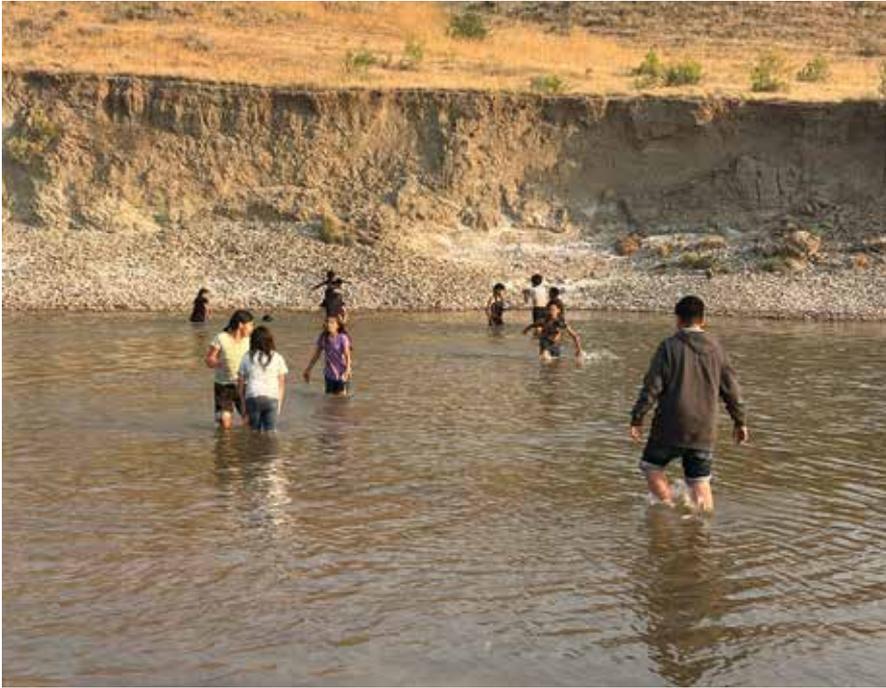
Nearby Wind River (30 yards) has now returned to being a popular recreational area for the local community.

Photos taken by Father Drew show children swimming in the river next to the treatment site, something unimaginable during the years when the lagoon's odor and condition made it uninviting.
